Author: Toomas Kaljas CEO / Chief Engineer  
Rak Tek Solutions Oy

## Preliminary analysis of Maxima shopping centre in Riga on 21.11.2013

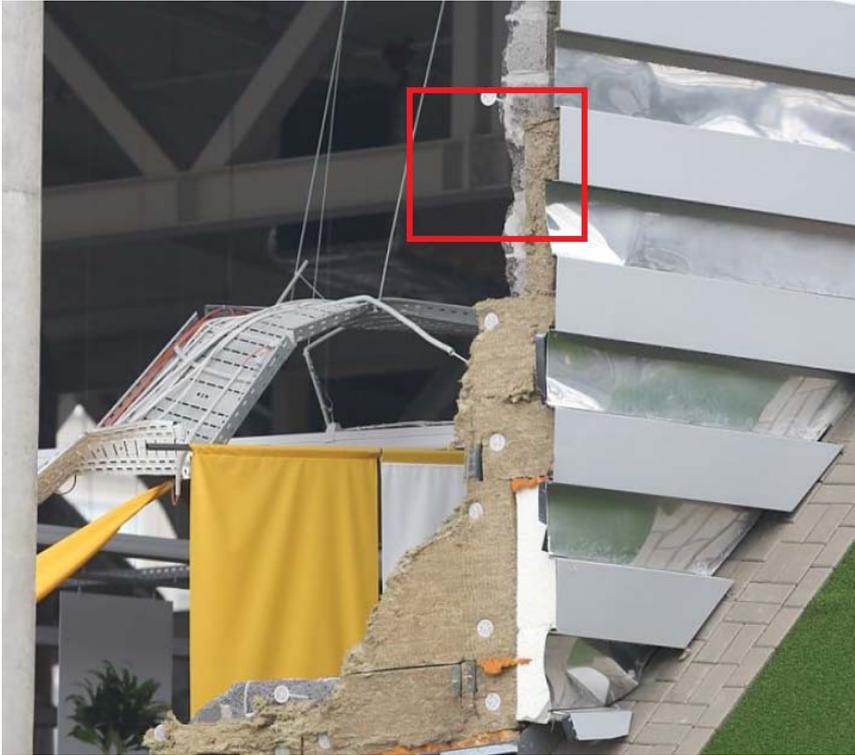
Based on photographic evidence presented in media, it is obvious that the primary cause for such collapse is the steel truss bolted tension connection. Steel truss, is made out of two pieces, which are assembled on site using bolted connections. The bottom chord tension connection is at least **two** times under-designed. The brittle connection is shown in figures **1** and **2**. The connection load carrying capacity can be manually calculated using yield-line method or analysed using modern FEM tools as shown in figure **7**.

**Figure 1.** Truss bottom chord is connected with end plates and bolts which are in between steel beam flanges. The quantity and sizes of bolts are not sufficient for massive steel beam section. Bolts should also be placed outside of flanges (see figure 5 for example)

4. At least eight additional bolts symmetrical to I section massive flanges would have been needed.
5. End plate thickness and dimensions should have been decided based on elaborate yield line method analysis, including all effects of prying force etc.

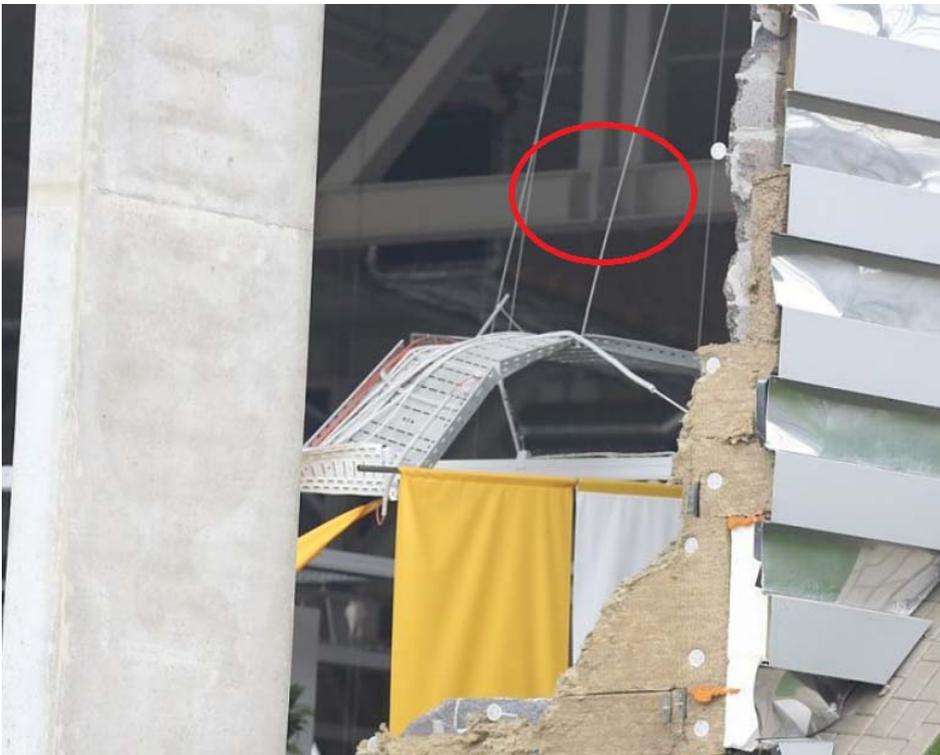
**Figure 2.** Same connection from different angle.

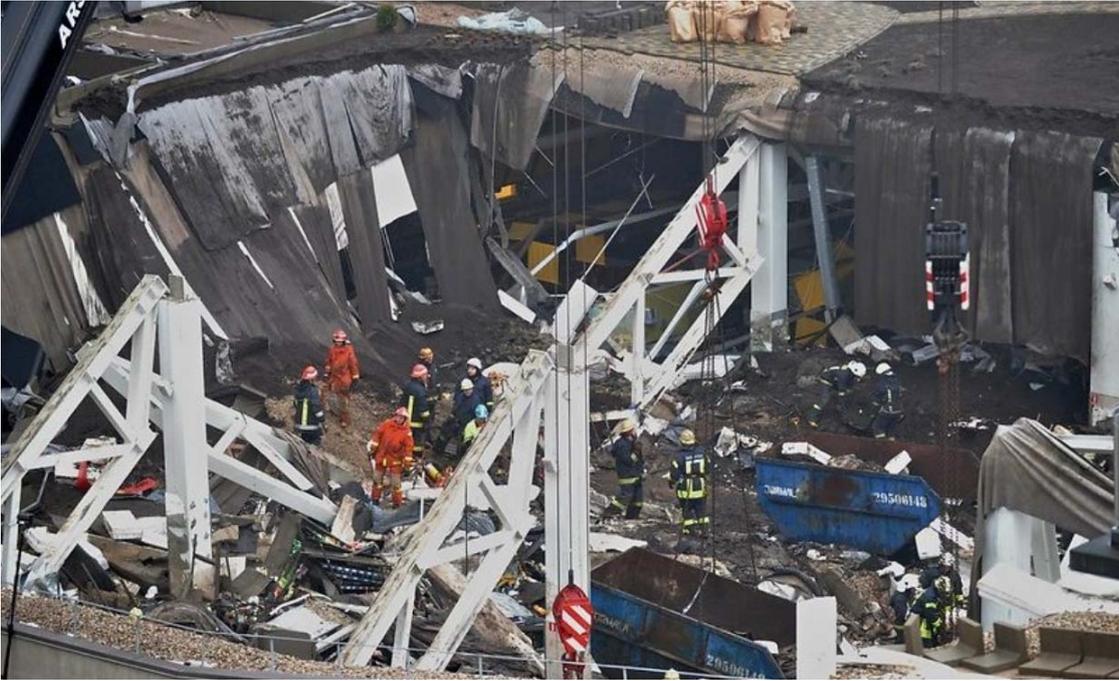
**Figure 3.** Steel trusses (**white**) have broken into two pieces and are buried under pile of rubble. The connection in figure 1 and 2 has caused brittle and sudden collapse without any warning. Several other design mistakes are also obvious but of less importance in this case.

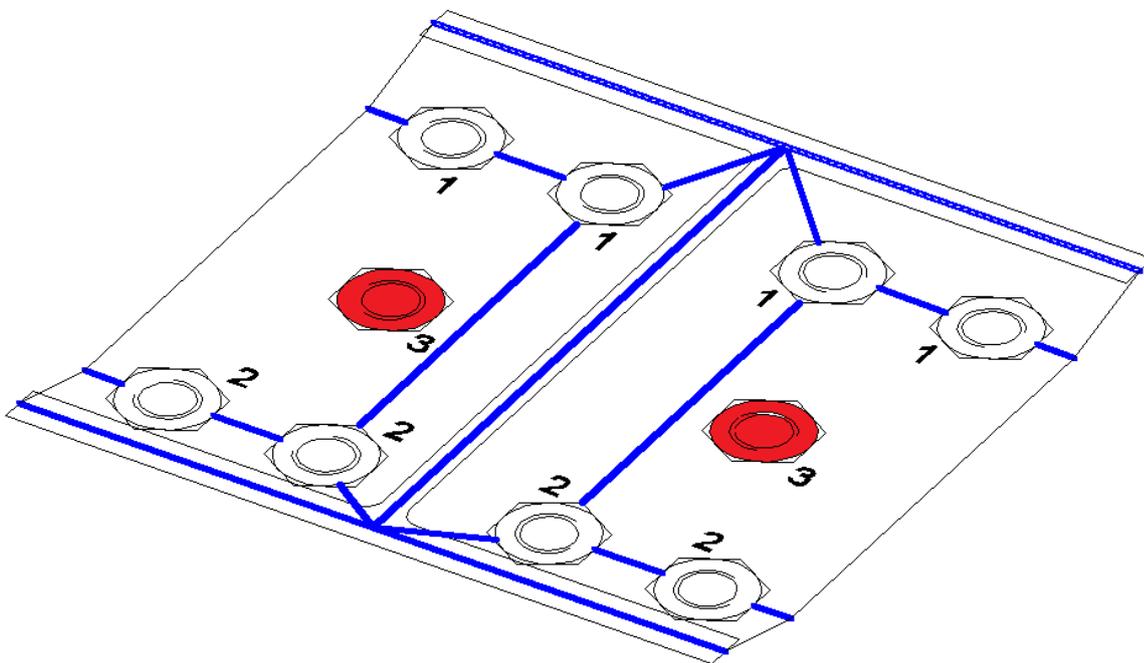
It can be seen from yield line analysis (figure **4**) and more advanced FEM-analysis, that bolt forces are not evenly distributed. Center bolt is completely useless in load carrying.

The uneven distribution of bolt loads is caused by **well-known prying force phenomena**. **EN 1993-1-8** states: “Where fasteners are required to carry an applied tensile force, they should be designed to resist the additional force due to prying action, where this can occur.”

**Figure 4.** Drawing of end plate in failed connection. **Blue lines** represent yield lines in end plate. Due to yielding pattern of end plate, bolts near the web of I-beam experience much higher forces. **Nr 3 row center bolts are completely useless**, visible on figure 4 as red.

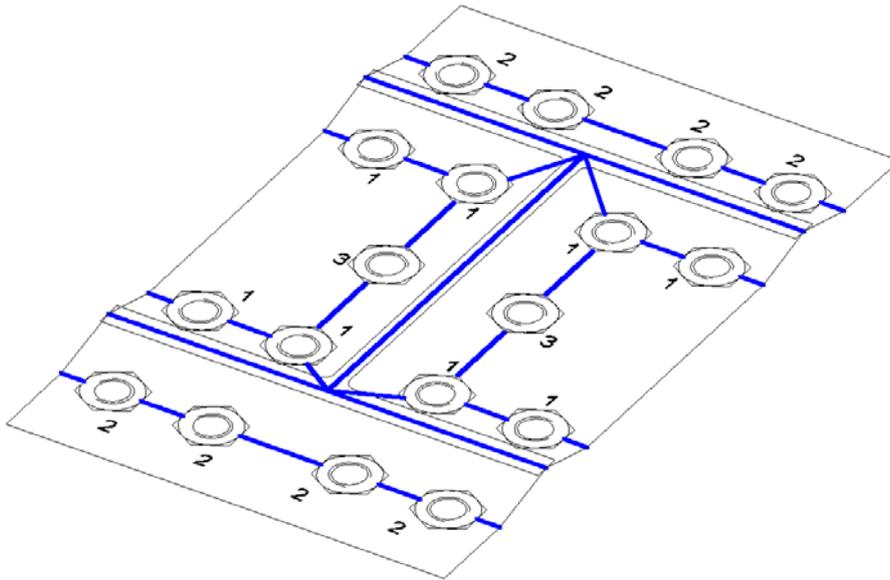
**Figure 5.** Example of properly arranged bolt placement. This connection shows the need of **eight additional bolts** outside the flanges (in rows nr 2). All bolts are useful in this configuration. **Blue lines** are representing plate yield lines.

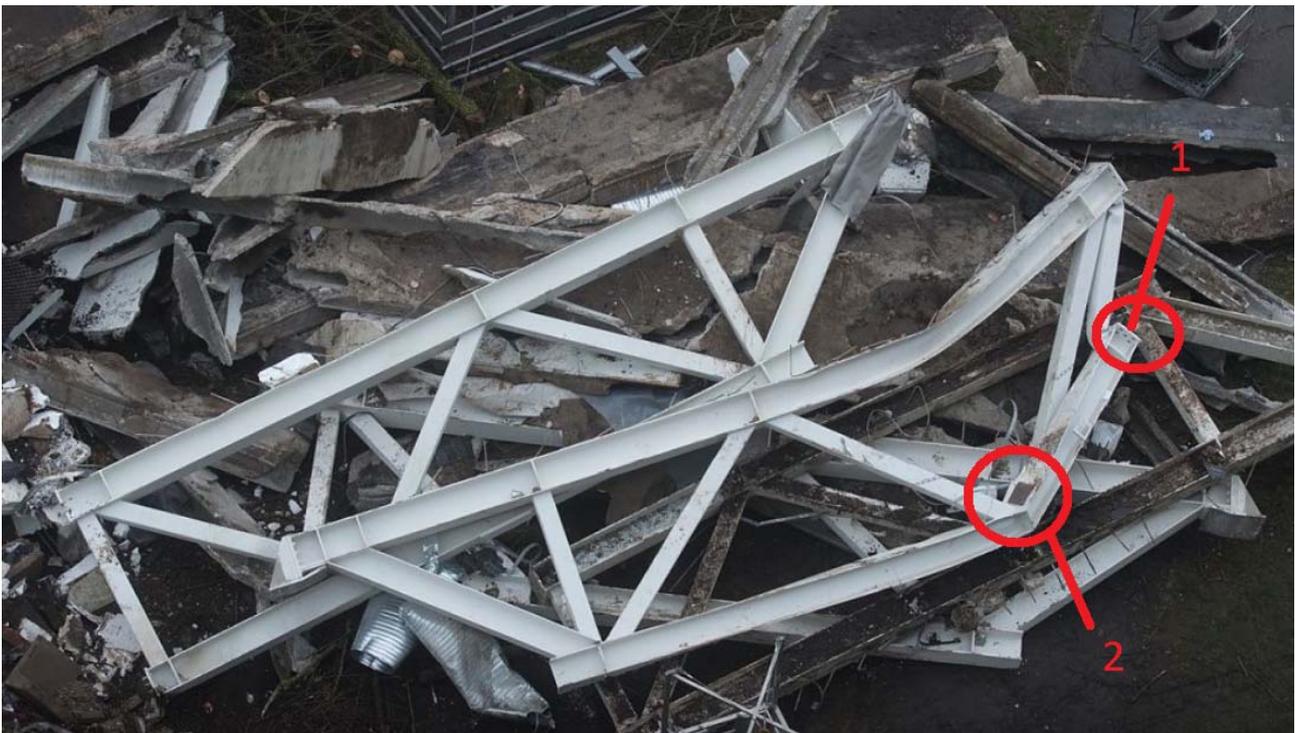
**Figure 6.** Tension connection (1) has failed from bolts just as theory would predict. Connection (2) has failed during the collapse, since this diagonal is in compression and does not fail or fracture in normal compression loading conditions. Only tension bars and connections rupture.

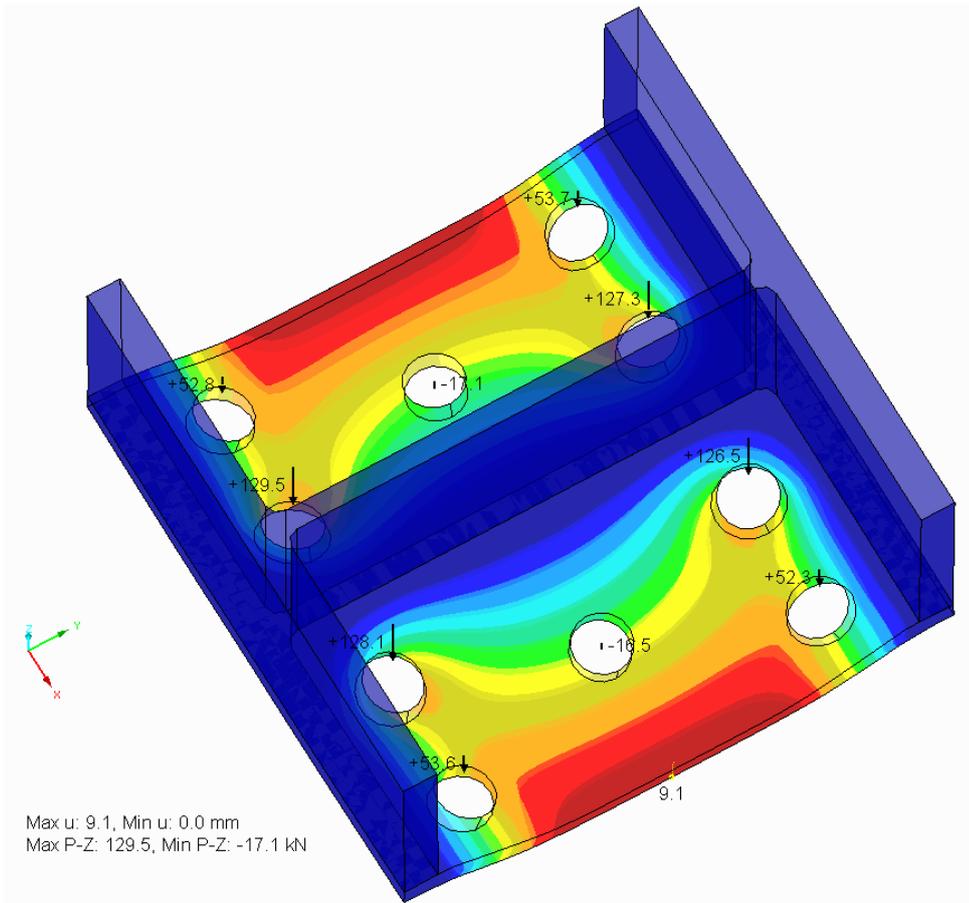
**Figure 7.** Example **FEM** model of the failed connection in Maxima shopping center. Center row **3** bolts are in compression (negative loading in bolts) (**totally useless**). Bolt forces are not evenly distributed. Maximum loaded bolts will rupture first and then all other will follow. Rupture can cause sound similar to “explosions”.

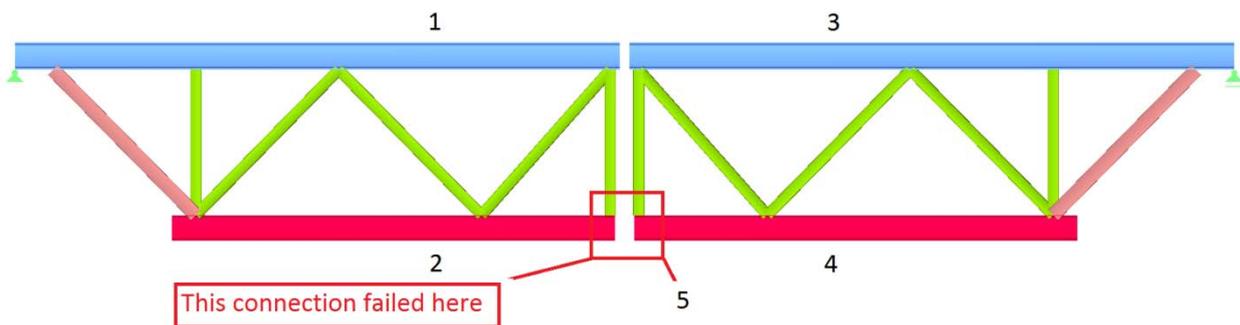
**Figure 8.** Static model of failed truss. Bolted tension -connection in figure 7 is placed in between of massive beams **2** and **4**. Due to fact that this connection was much weaker than beams **2** and **4**, the truss failed in a brittle manner without any prior warning.
