Author: Toomas Kaljas CEO / Chief Engineer  
Rak Tek Solutions Oy

## Preliminary analysis of Maxima shopping centre in Riga on 21.11.2013

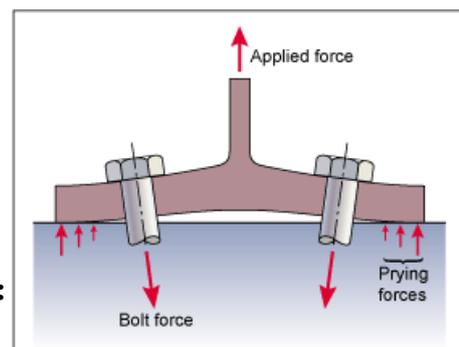
Based on photographic evidence presented in media, it is obvious that the primary cause for such collapse is the steel truss bolted tension connection. Steel truss, is made out of two pieces, which are assembled on site using bolted connections. The bottom chord tension connection is at least **two** times under-designed. The brittle connection is shown in figures **1** and **2**. The connection load carrying capacity can be manually calculated using yield-line method or analysed using modern FEM tools as shown in figure **7**.

The uneven distribution of bolt loads is caused by **well-known prying force phenomena**. **EN 1993-1-8** states: “Where fasteners are required to carry an applied tensile force, they should be designed to resist the additional force due to prying action, where this can occur.”

**Figure 1.** Truss bottom chord is connected with end plates and bolts which are in between steel beam flanges. The quantity and sizes of bolts are not sufficient for massive steel beam section. Bolts should also be placed outside of flanges (see figure 5 for example)
